Public Buildings Enhanced Energy Efficiency Program

Final Report Investigation Results For Rosemount National Guard TACC

Date: 4/5/2012

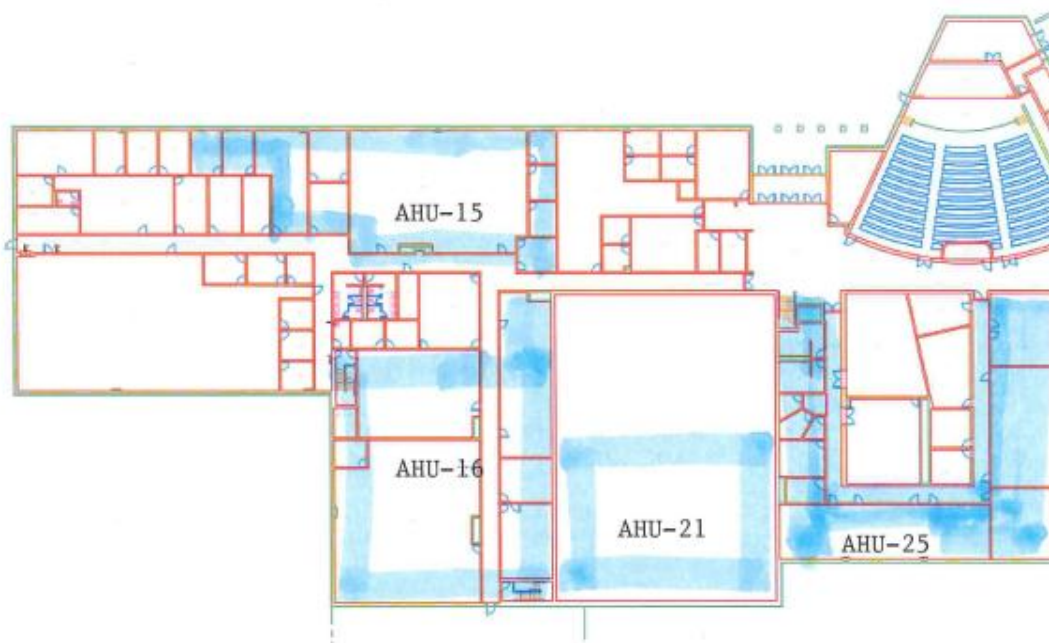
There are a total of 32 AHUs. Four air handlers were investigated, as is shown on the floor plan below. The spaces included were: the boiler and chiller room, the gymnasium, the main office, and a typical classroom. Each of the air handling units is separately controlled. The units are generally mounted in the ceiling space above individual rooms, and have an associated control box, including an analog time clock that is also in the ceiling space. The timers and controls are difficult to access and therefore are rarely adjusted by the staff. Because the clocks often have the incorrect time of day, the spaces tend to be set for a constant temperature 24 hours a day, seven days a week. There are approximately 71 VAV boxes associated with these AHUs, most of the VAVs contain reheats.

Main Floor of Rosemount Training and Community Center, showing areas investigated in the PBEEEP Study (blue shading).
